# SGS North America, Inc. Hurricane Ida Building Evaluation

151 James Drive West  
St. Rose, Louisiana

Issued for Review  
Project #2021.151

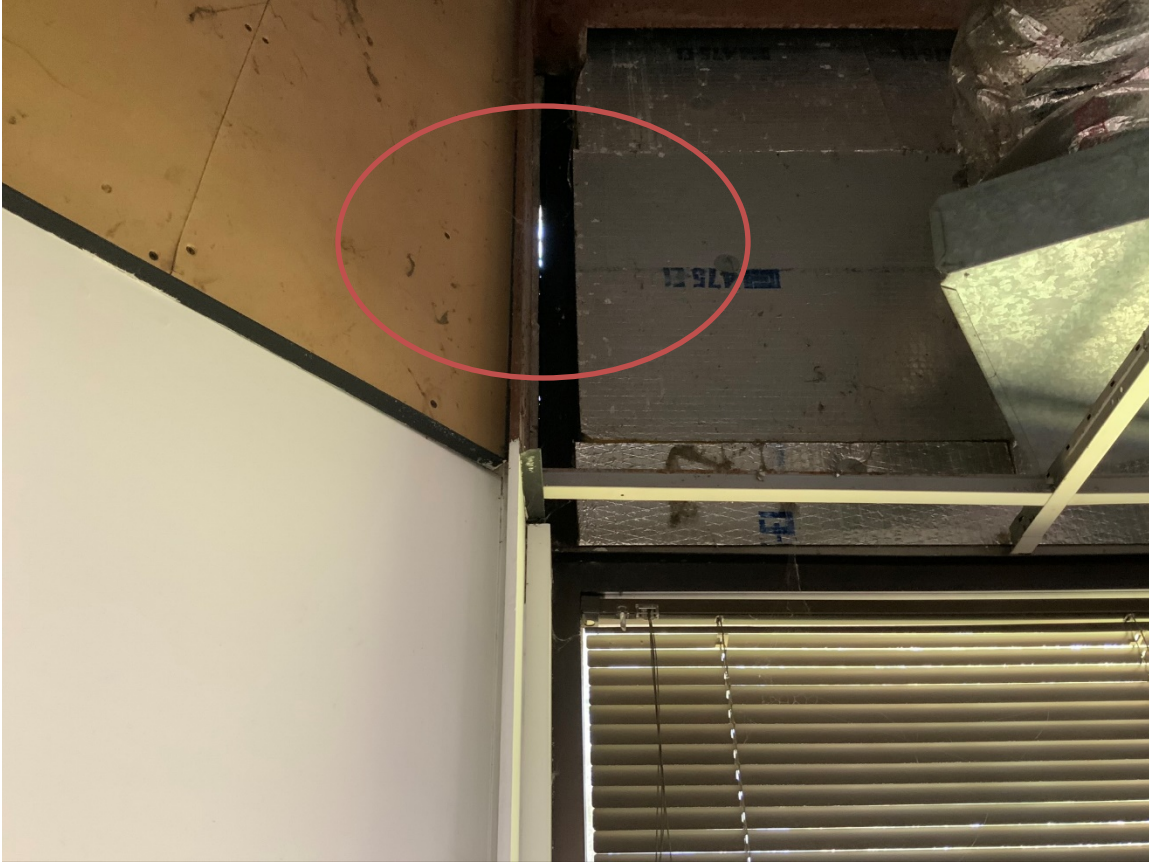
Figure C.2: East Front Wall in Office Area

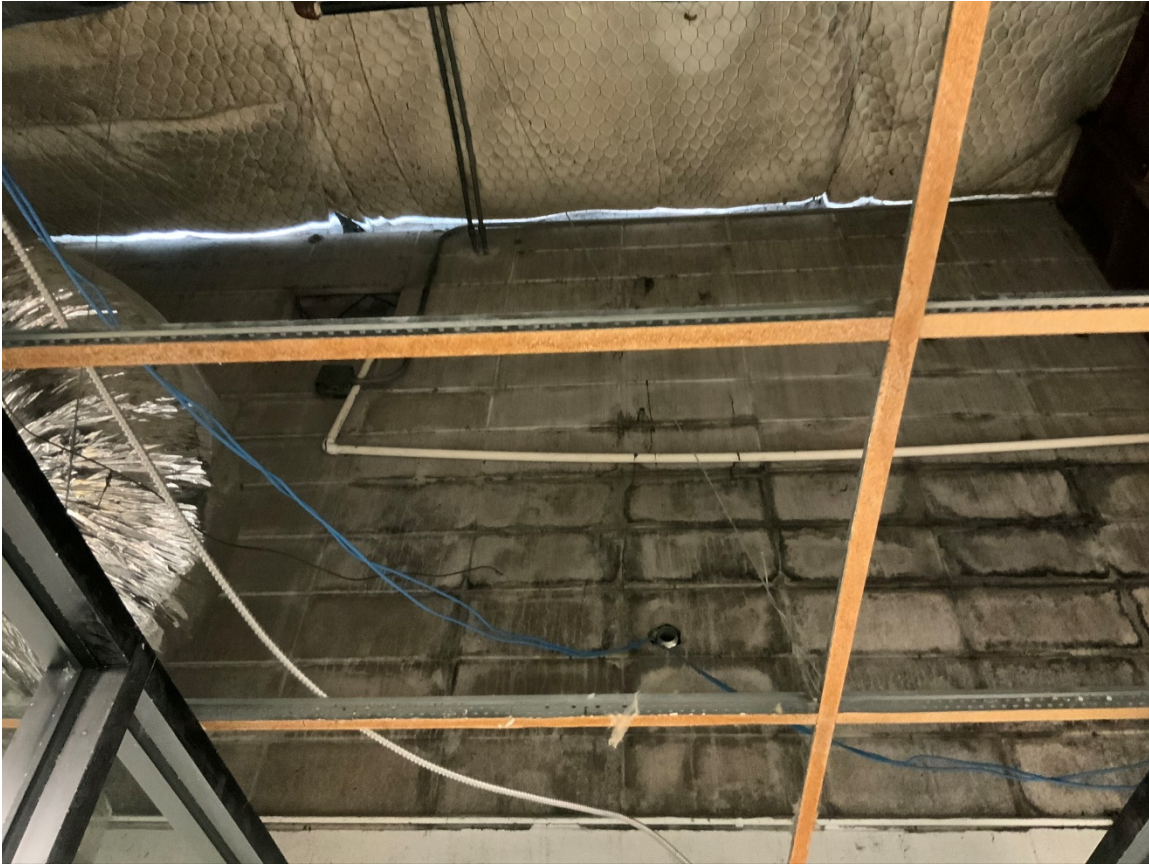
Hurricane Ida also had devastating effects on the roof by peeling up much of the fiberglass coating and blowing over or damaging many of the exhaust fans. The metal flashing was also peeled from the West lab, exposing much of the area to the outside air.

Figure E.1: West Lab Ceiling (where flashing removed due to Hurricane IDA).

Due to the deficiencies in the existing roof, we recommend a new roof be applied. This will require removal of the fiberglass coating and original roof membrane to expose the existing lightweight concrete. To achieve current IECC R-values on the roof, we recommend installation of polyisocyanurate board insulation to the existing roof which will be sloped to achieve the proper drainage as originally designed and a TPO membrane applied. During the process of replacing the roof system, all mechanical equipment will need to be raised to a minimum of 14” above the roof and

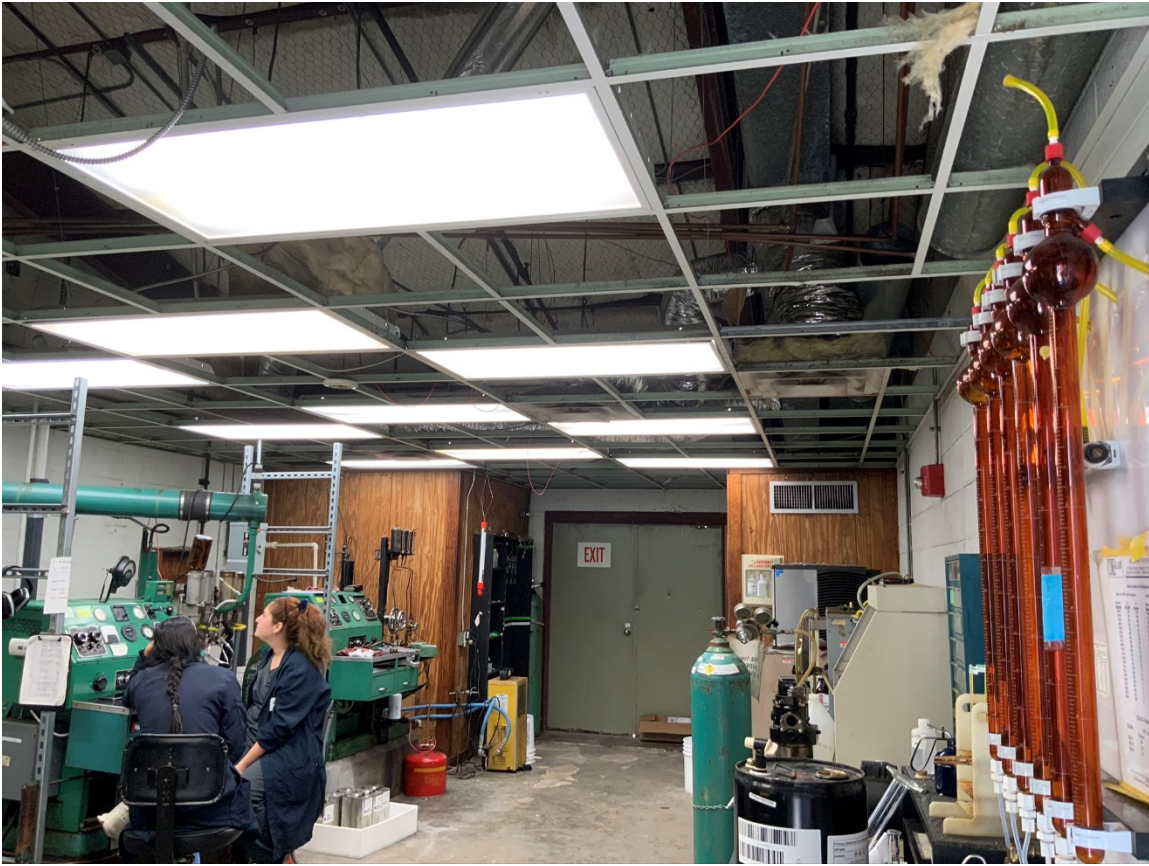
Figure E.4: West Lab Octane Room

The West Laboratory is served by three (3) rooftop package units (sitting on the Central Lab roof) and associated ductwork. While part of the original design, two (2) of these unit have been replaced within the last 10 years. Most ventilation fans for this area are not working (some were damaged during Hurricane Ida) and some supplemental HVAC has been added to the octane room to help control temperature.

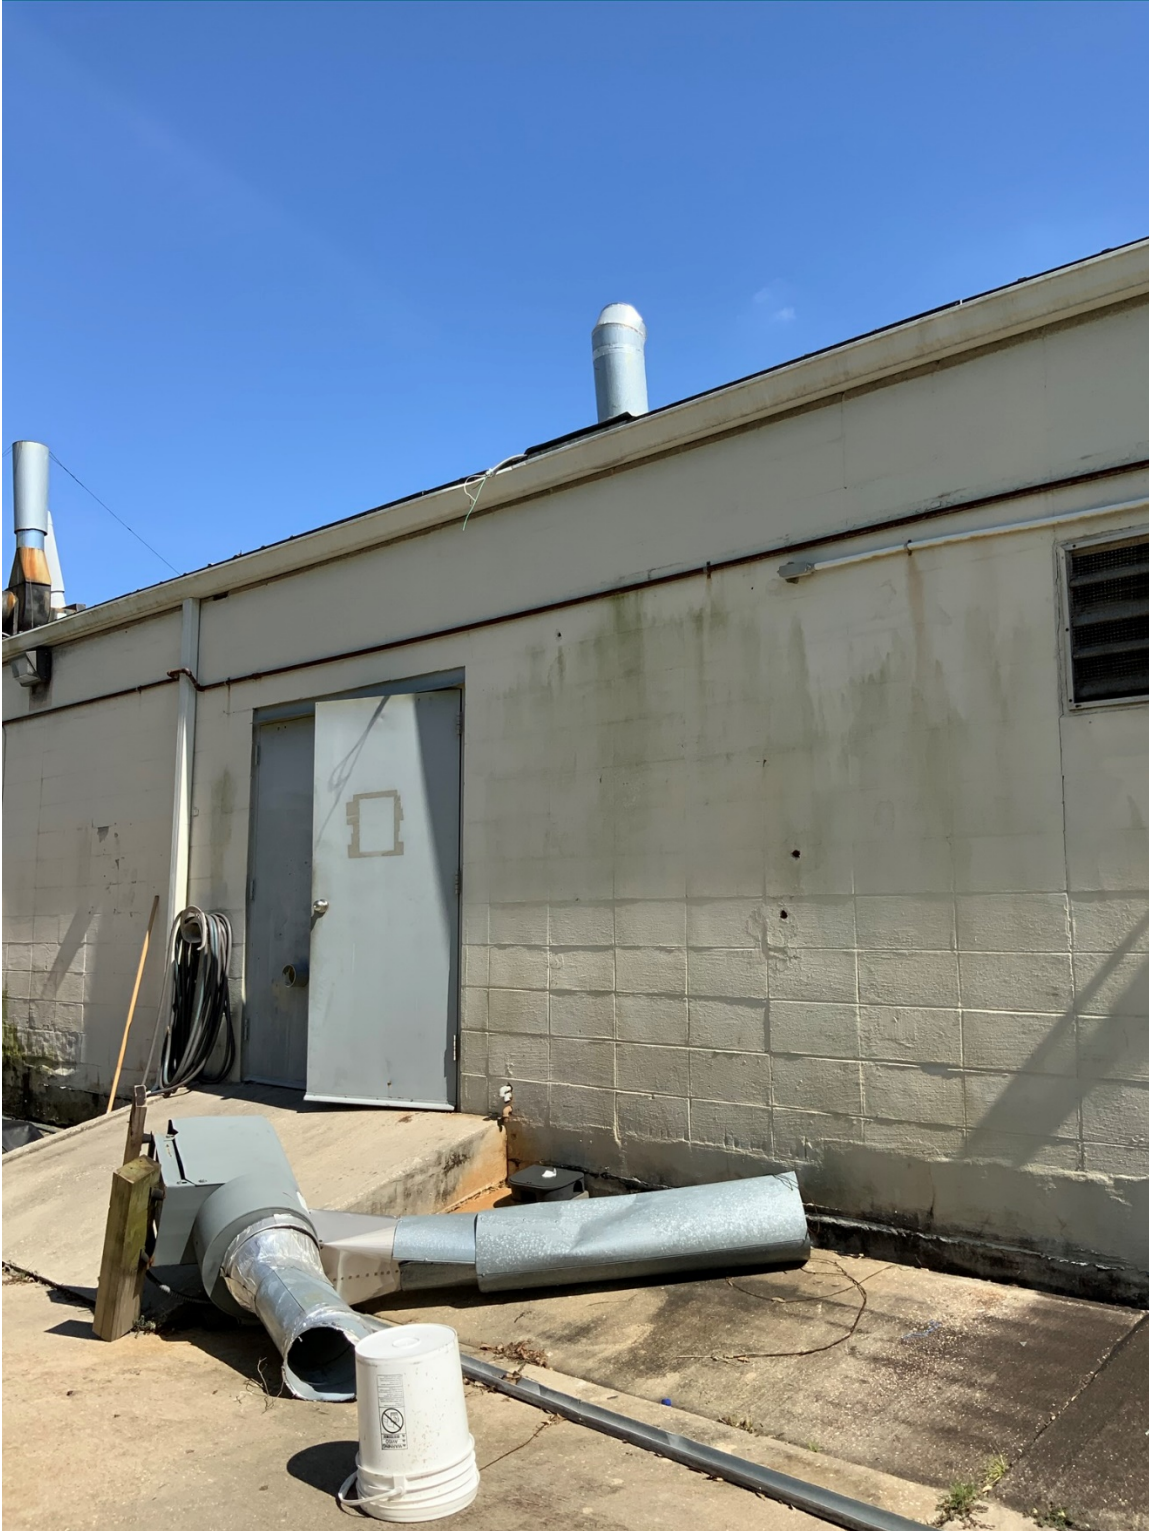
Figure E.5 – West Lab Maintenance (fan damaged during Hurricane IDA).

Ideally, new exhaust fans and outside air intakes will be installed in conjunction with the new roof work.
