# ***A Buyer's Choice Home Inspections***

## **Property Inspection Report**

627 Marian Crescent NE, Calgary, AB, T2A 2Y5

Date of Inspection: 1/16/2016 Time: 9:00 AM  
Order ID: 272

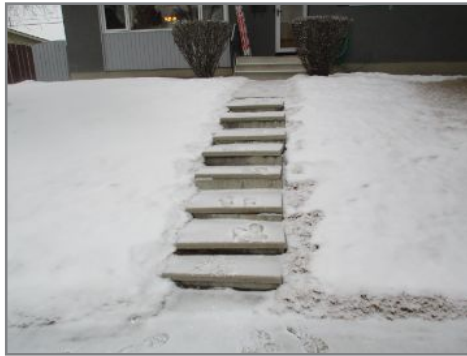
- Sidewalk was noted to be in good condition at time of inspection.
- Due to snow or ice cover, the comments reflect only the visible portion of the lots and grounds.
- Sidewalk on the side of the home has settled towards the home and drainage is directed towards the home. Recommend correcting so drainage is away from the home.

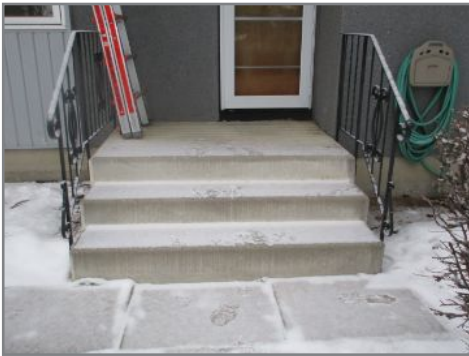
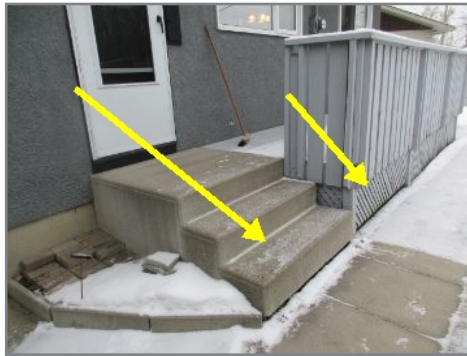
- Step/stoop was noted to be in good condition at time of inspection.
- Due to snow or ice cover, the comments reflect only the visible portion of the lots and grounds.
- Partially snow covered not fully inspected.
- Stairs with three steps or more should have hand rails. As a safety precaution we recommend installing hand rails.
- Normal settlement / separation crack at concrete walk / steps junction. Recommend sealing this crack to keep moisture and insects and rodents out from under the stoop.

Recommend having hand rails on all stairs with 3 steps or more as a safety concern

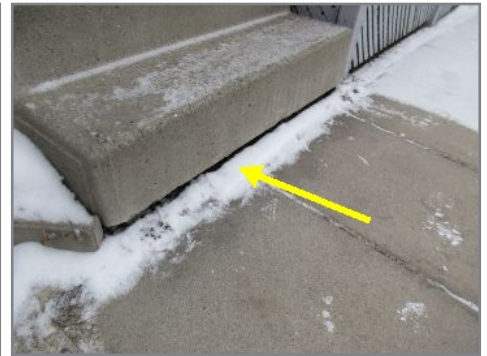
Recommend filling gap to keep rodents and insects out

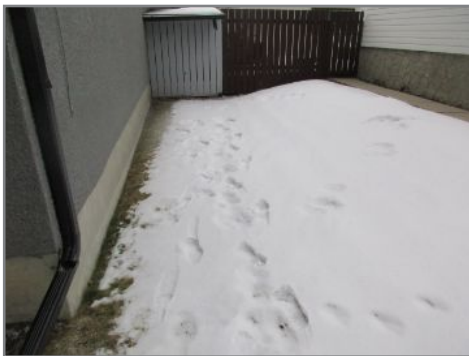
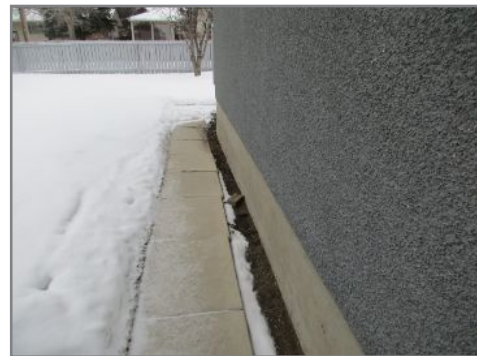
- **The exterior grading is improperly sloped towards the foundation. Water can intrude into the interior. Recommend creating the proper slope away from the foundation with a minimum slope of 6 inches for the first 10 feet to allow for proper drainage.**

Sidewalk has settled and allows water to drain towards the foundation. Recommend improving the grade so water flows away from the home

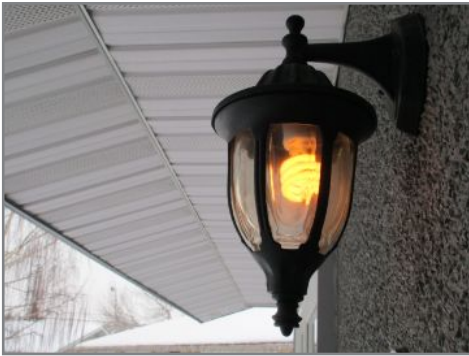
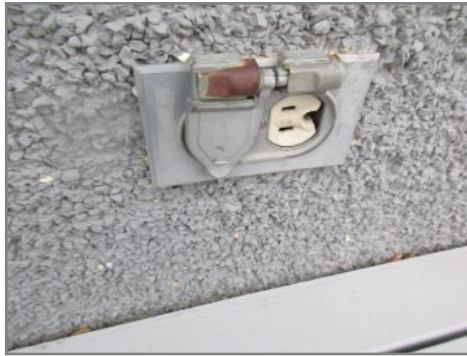
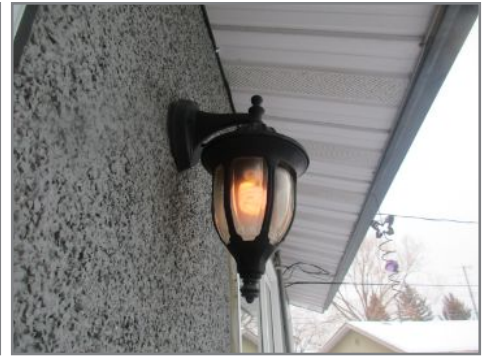
- No major system safety or function concerns noted at time of inspection.
- Outlet cover is not waterproof.

Recommend replacing cover to  
keep moisture out of the subwall

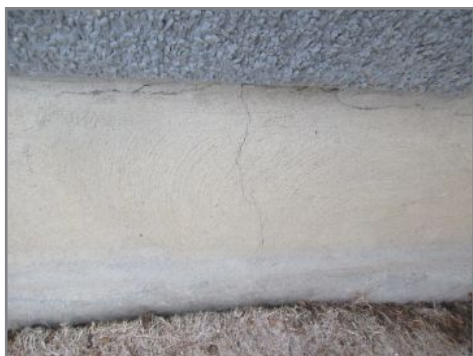
Common settling cracks noted. Recommend monitoring and sealing if required

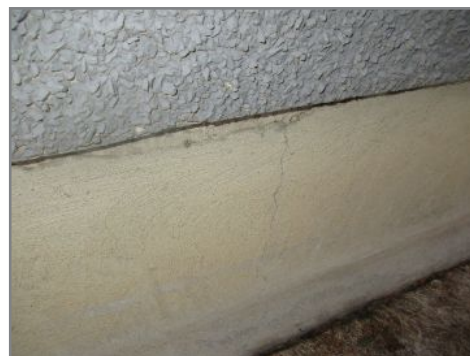
Common settling cracks noted

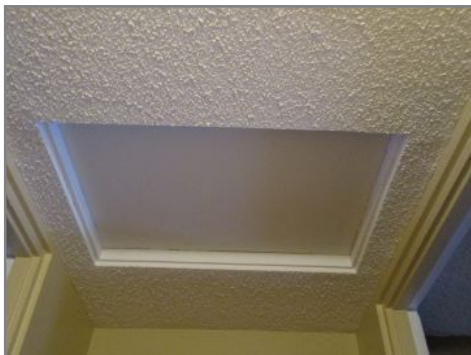
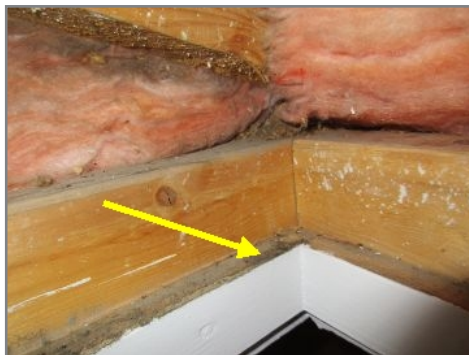
- Appeared functional - with insulation over hatch door.
- **Recommend adding weather stripping to edges of attic hatch to make a tighter seal. This will stop heat loss into the attic which can cause higher condensation in the attic which can lead to mold or rot. Adding it will also help lower heating costs.**

Recommend installing weather stripping around attic hatch

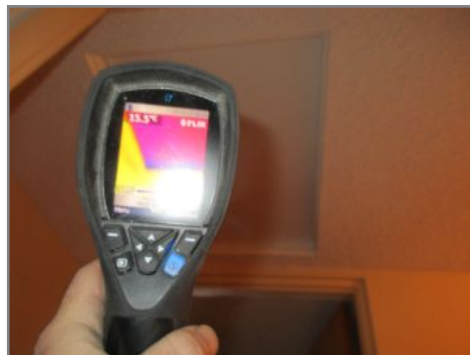
Thermal imaging shows heat loss at attic hatch

Dark areas in thermal imaging indicate heat loss due to poor insulation and weather stripping missing on attic hatch

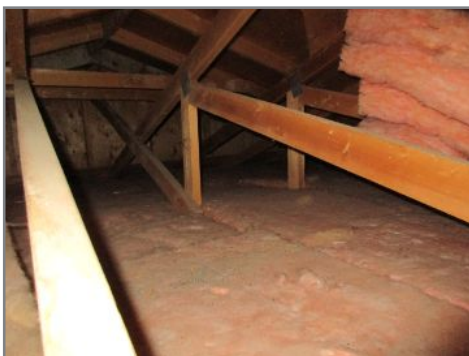
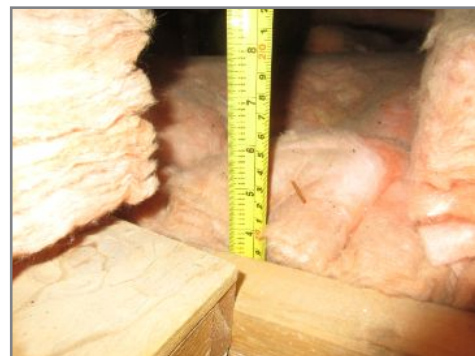
- **IMPROVE:** The house has only a minimal amount of visible insulation. Expect high heating and cooling energy costs. Recommend having the home professionally insulated to reduce energy expenses.

Recommend improving insulation levels

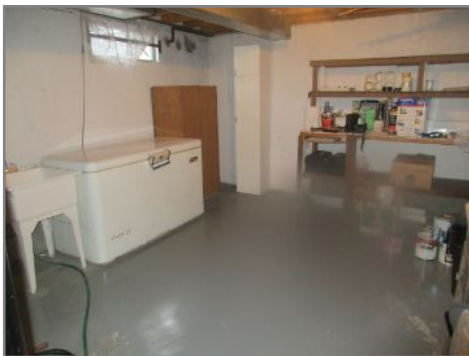
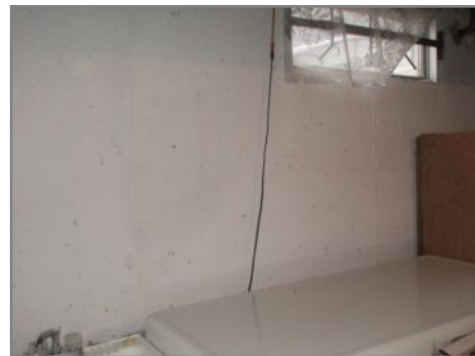
Recommend installing insulation and vapour barrier

- Recommend adding insulation to perimeter of structure to enhance the homes heating efficiency.
- Vapour barrier has not been installed in some areas. Recommend installing to prevent moisture and possible mold from developing.

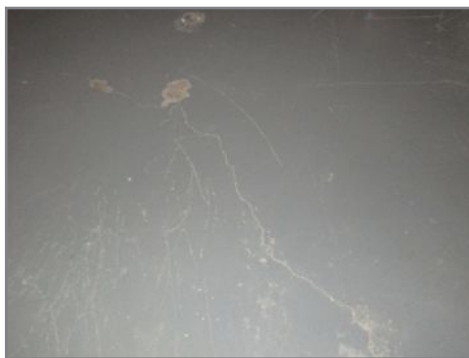
Common settling cracks noted

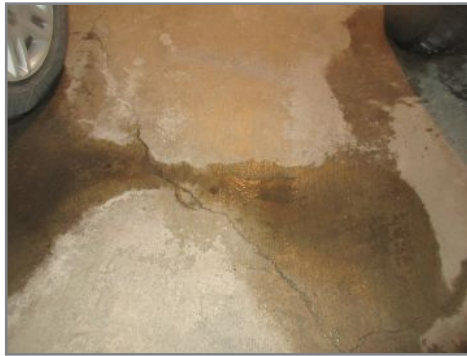
- Floor appeared to be in good condition at the time of the inspection.
- Settling cracks noted in floor which is very common for the Calgary area. This is not a structural concern at the time of the inspection.

Common settling cracks noted

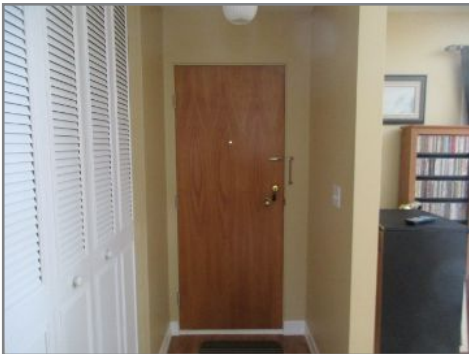
Front entrance

- Hollow wood door noted.
- Wood door noted.
- Wood door with glass panes noted.
- Sliding patio door noted.
- No function concerns noted at time of inspection.
- Weather stripping is not installed on back and front doors.

Recommend installing weather stripping on exterior doors

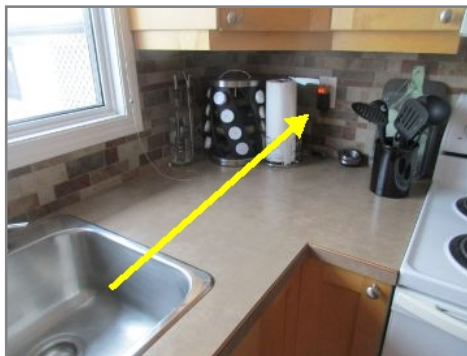
Recommend updating all outlets within 4 feet of a sink to have GFCI protection

1. Replacing the current standard outlets with GFCI outlets
2. Replacing the breaker currently protecting the electrical circuit which contains these bathroom outlets with a GFCI breaker.

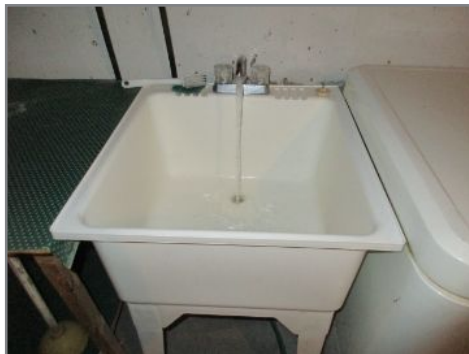
- Plastic sink located in furnace room.
- Drain is not connected correctly. Recommend having a qualified plumber to evaluate and repair as needed.
- Slow drain at sink. Recommend clearing.

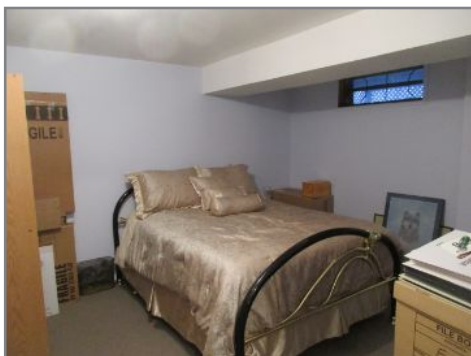
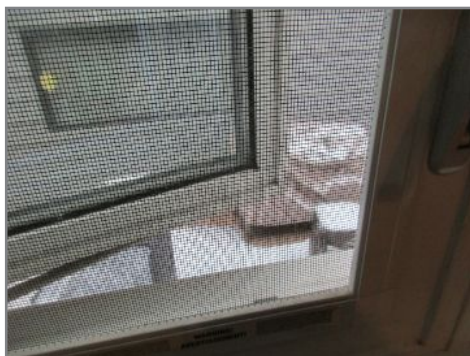
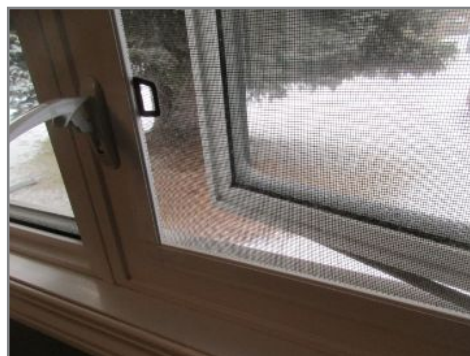
- The windows were tested, and are functional at time of inspection.
- Hardware missing on one window so could not test it.
- **Not an adequate sized window in basement bedroom, this is not to code and is a safety issue. All bedrooms should have a window large enough to be used as an emergency exit in case of fire. The floor to window sill height can be no more than 44 inches and the width of the open window should be 20 inches and the height 24 inches. This room should not be used as a bedroom.**
- **Window well heights for bedroom windows should be no more than 44 inches high so they can have emergency (egress) exit. The horizontal area of the window well should be at least 9 square feet and have a horizontal projection of at least 36 inches.**

Basement window does not meet emergency exit standards for a bedroom

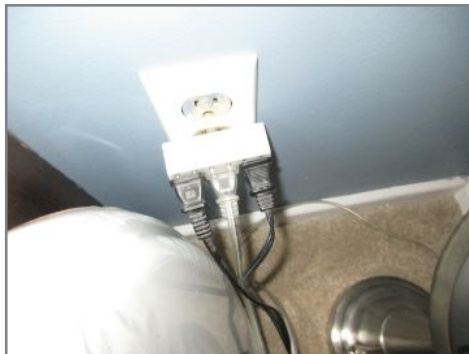
We do not recommend using this type of multiple splitter for it can overheat

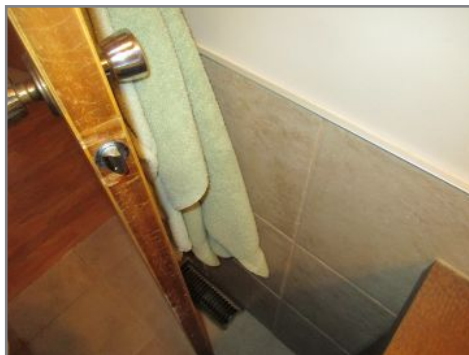
Observations: Hollow wood door noted., No function concerns noted at time of inspection., Some door stop(s) missing / ineffective; recommend installation to avoid unnecessary wall or door damage.

Recommend installing door stops to prevent wall damage from door knob
