Color Differential:

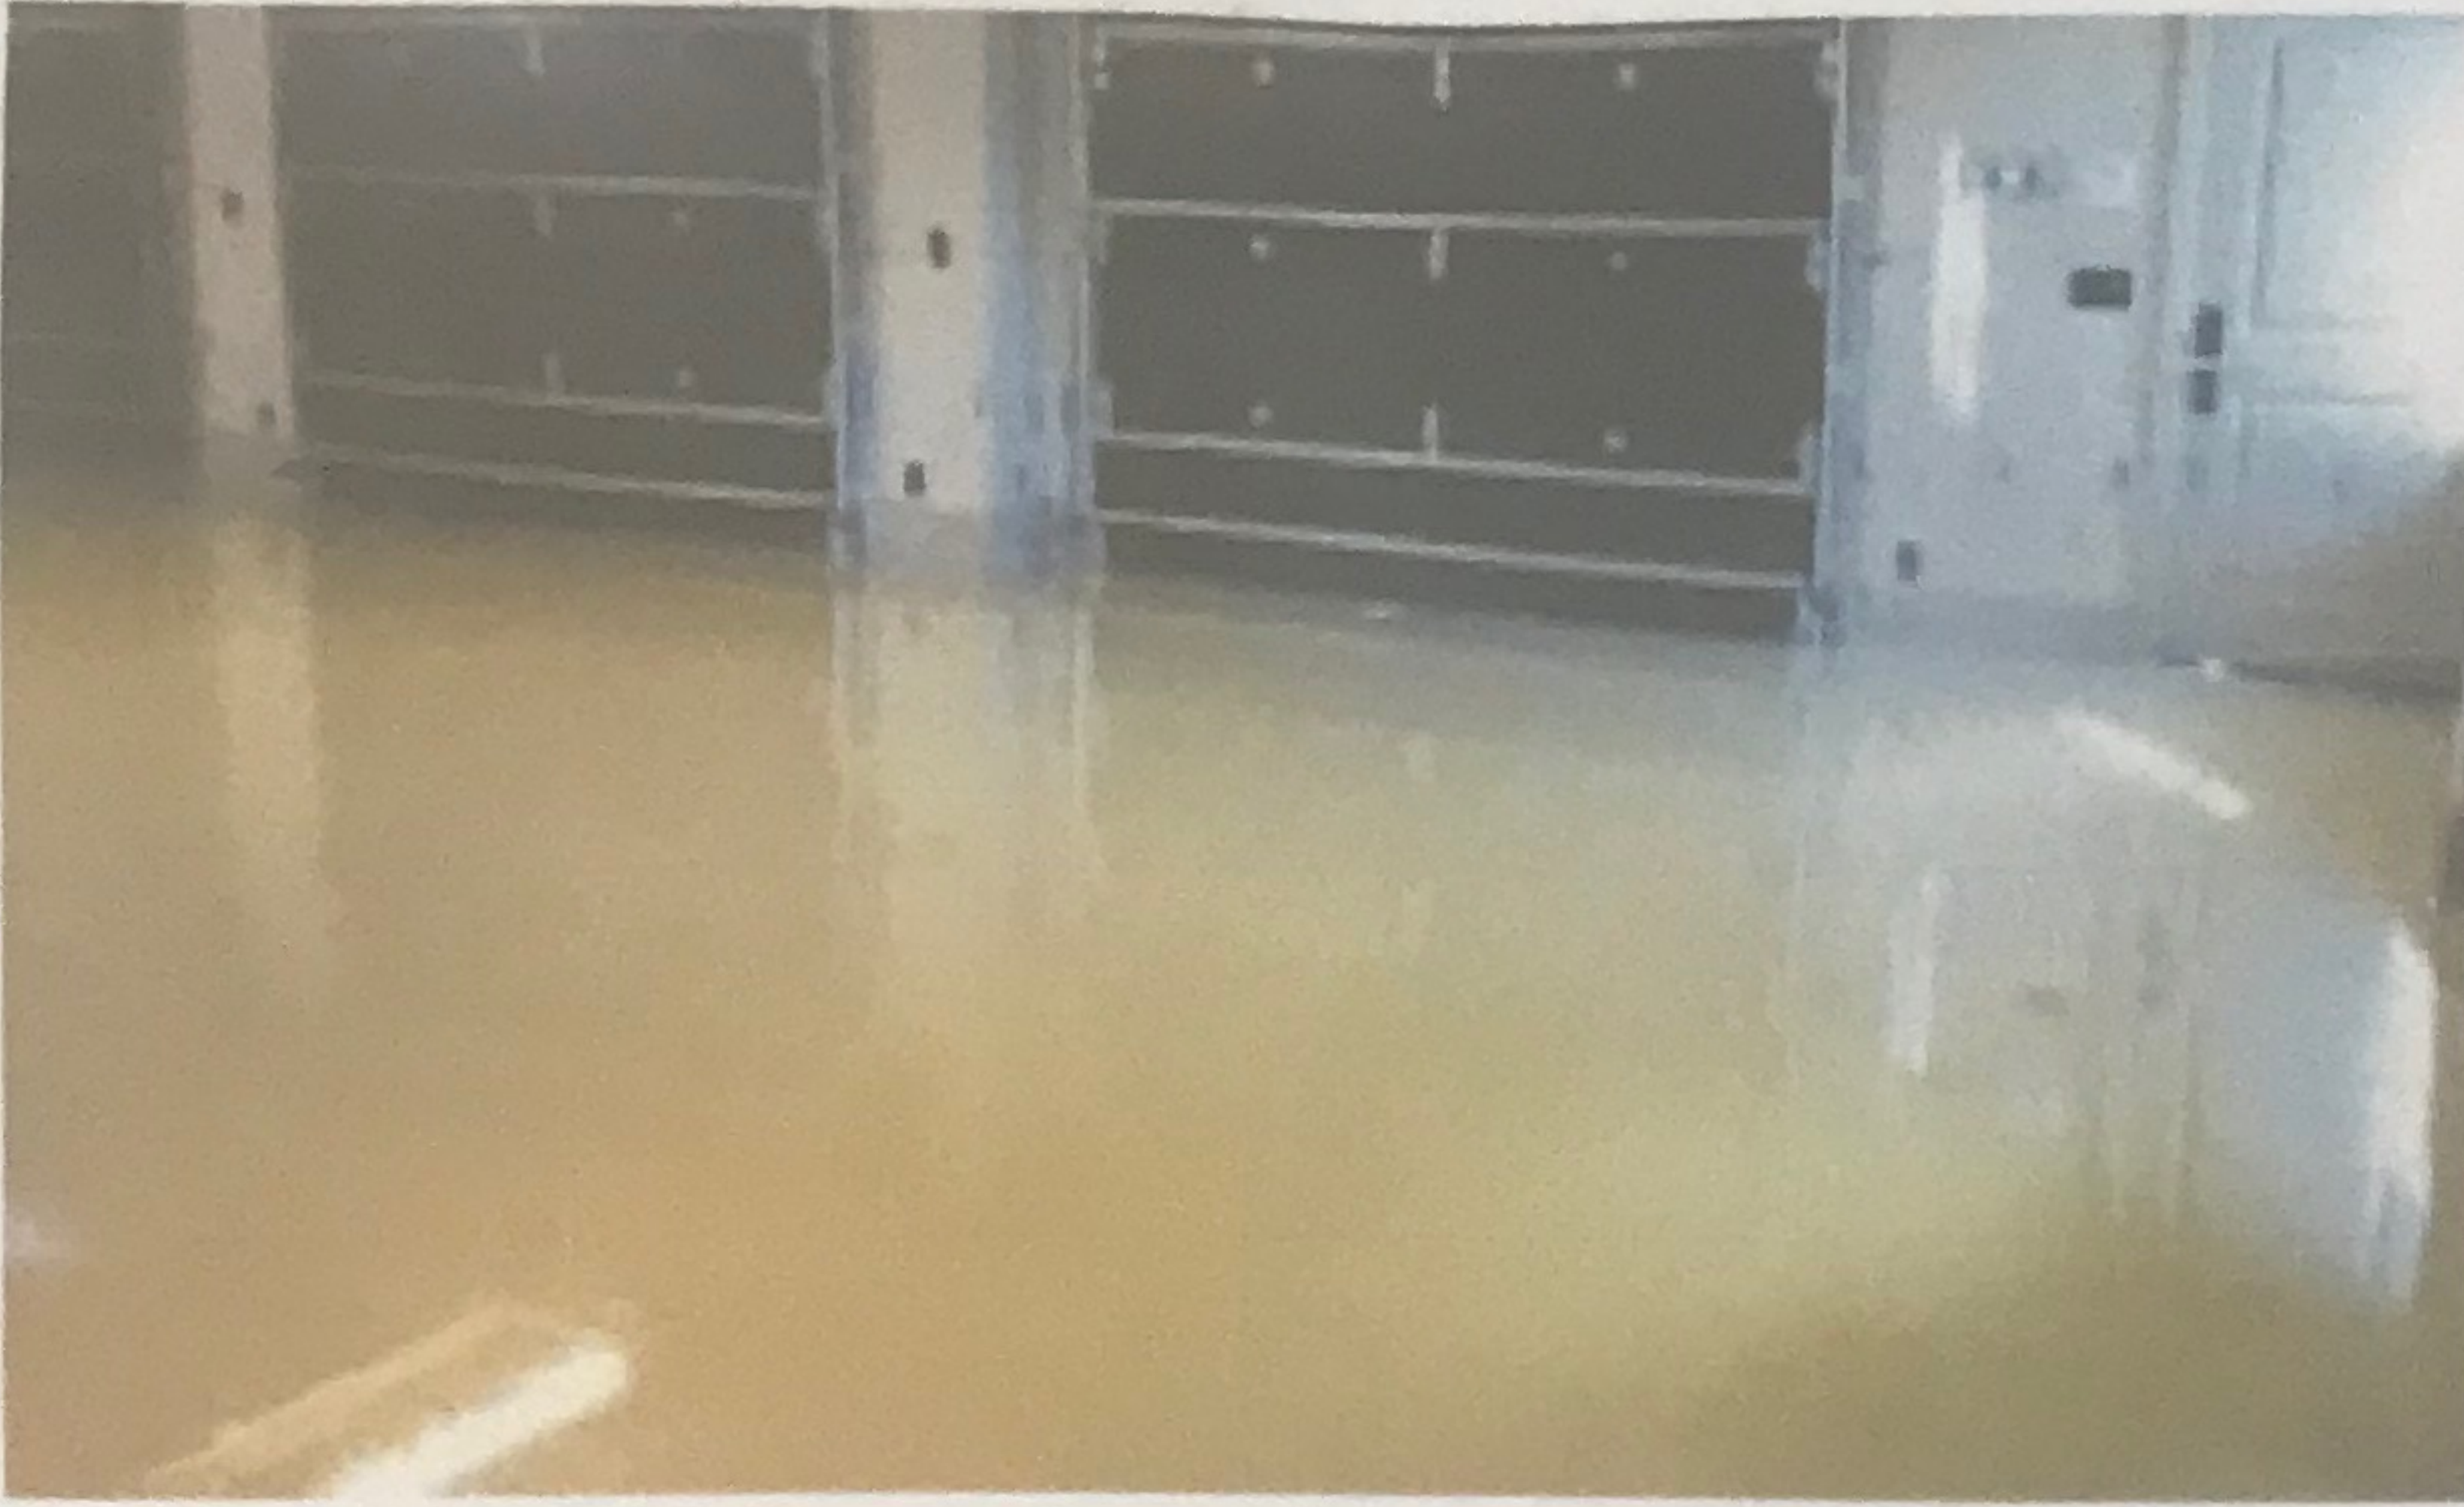
Difference in color or shading of topcoat.

Retouching after 15 minutes: Color float issues arise when a pigmented epoxy has been applied and is re-touched or rolled again after sitting for 15 minutes or longer. Different shades in the color may result.

Using different batch numbers: Coloring can vary from batch to batch. Different batches used on the same project can result in color variances.

Back roll the entire area always using an 18", woven, shed-resistant, 3/8" nap roller. Always try to go across the entire area from side-to-side.

When possible, recoats should always be completed with the same coating batch.

If batches are different, blend colored (base) side first before adding activator.

If material needs to be re-touched or rolled for any reason, it needs to be done within 10 minutes of application.

Always check to make sure that you have the same batch number on the pigmented side of the product prior to adding the activator.
