Sample Graphic Themes

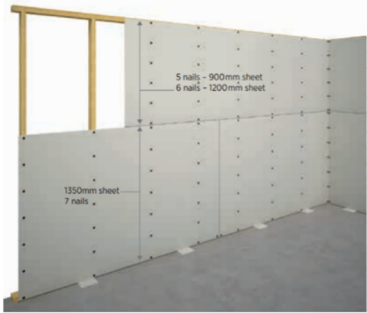
Figure 31: Nail fixing to walls (single nails)

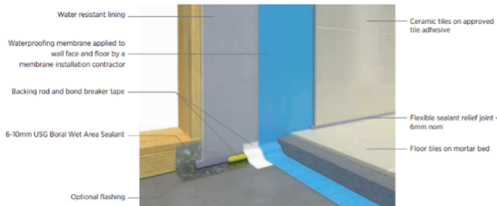
Figure 58: Waterproofing of basin

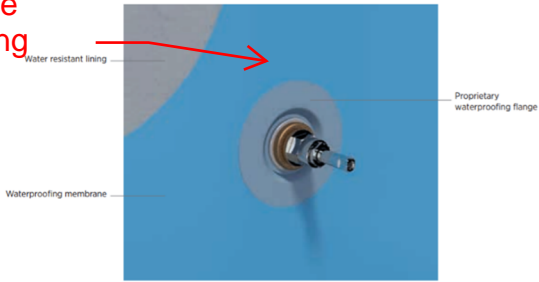
Figure 67: Plumbing Penetrations – Sealed

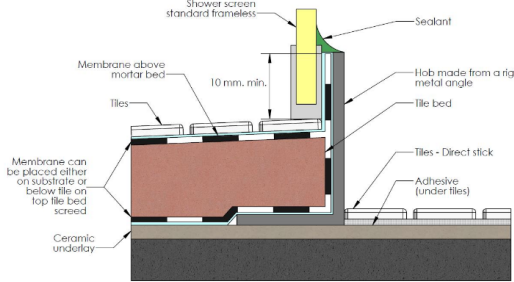
Figure 68: Plumbing Penetrations With Proprietary Waterproofing Components

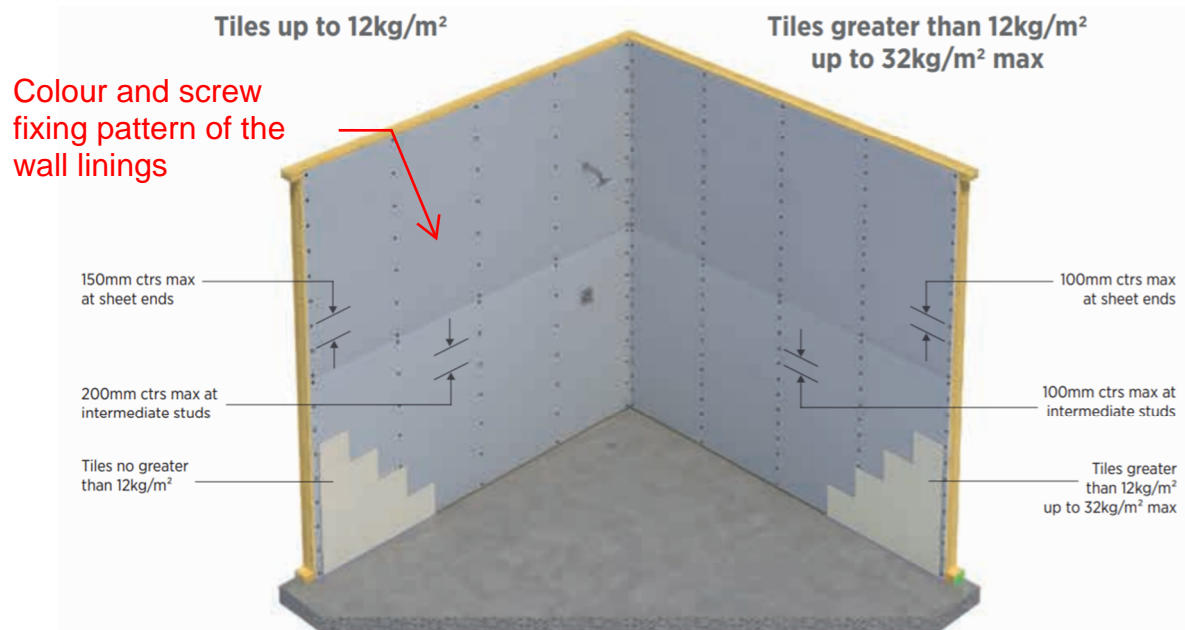
Figure 52: Plasterboard Fixing in Tiled Areas
