MAINTAIN
— MECHANICAL INC —

PREVENTATIVE MAINTENANCE REPORT

Prepared for:
Forge Road Complex
2024/09/03

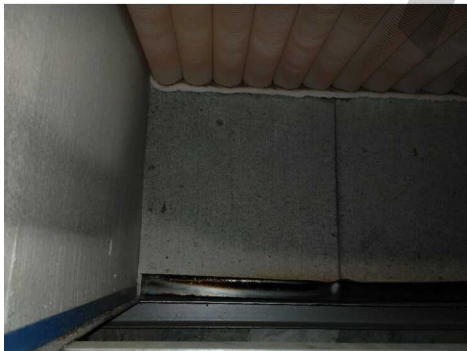
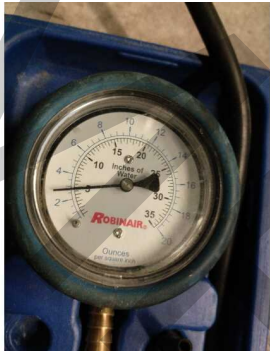
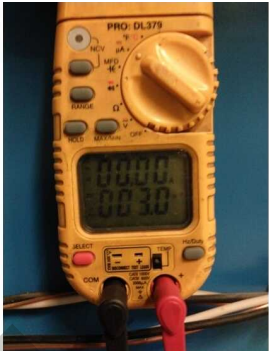
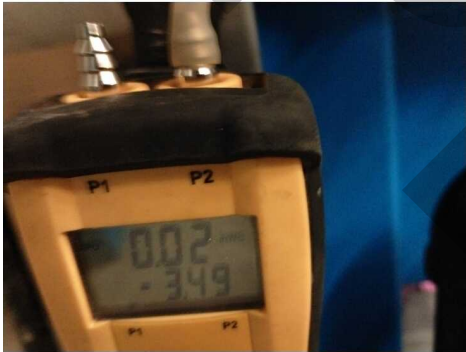
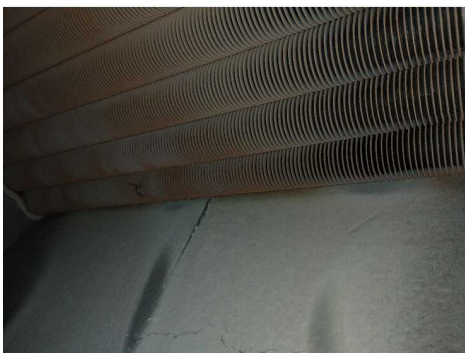
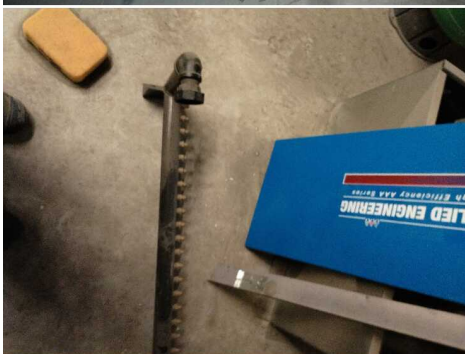
Asset Register - Boiler					
Asset ID	Make	Model	Serial	Location	Results
989	Super Hot	AAA-1800-NM	AIAH-2866	Mechanical Room	Fail
<div>Test Reading:<p>Are there any leaks present? (Water, Gas & venting): No Is the boiler operational upon arrival?: Yes Target setpoint / Outside Temperature (Ambient Air): wwsd Visual ignition test: Acceptable (smooth light off) High-limit test: Pass Safety relief valve test: Pass Flow switch test: Pass Low-water cutoff test: Pass Condensate trap & neutralizer condition : Not Applicable Heat exchanger / Refractory Condition (Atmospheric Visual Only): Not acceptable (fouled, leaking, or plugged/dirty) Boiler filters: Non-applicable Combustion Motor (If applicable) : Not Applicable Flame Signal: Acceptable / Within Range HSI Amperage : Flame Rod / Spark Rod Cleaning: Cleaned Burner Cleaned & Inspected: Cleaned / Acceptable Static Gas Pressure (if applicable) : Acceptable / Within Range Dynamic Gas Pressure (if applicable) : Acceptable / Within Range Manifold gas pressure: Acceptable / Within Range</p></div> <div>Test Notes: (If Applicable)<p>Refractory cracked and needs replacement Unit will have to be pulled off the wall Need pallet jack to move boiler off the wall 2 techs 20h Superhot Aaa1440nm Ajai-3152</p></div> <div>Photos: (If Applicable)</div>

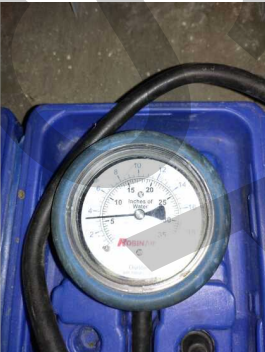
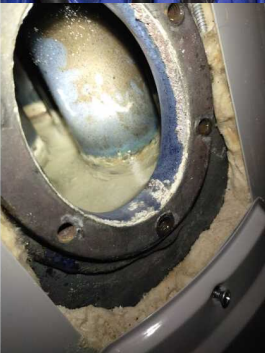
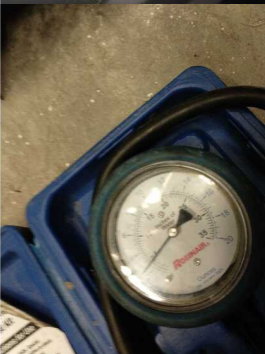
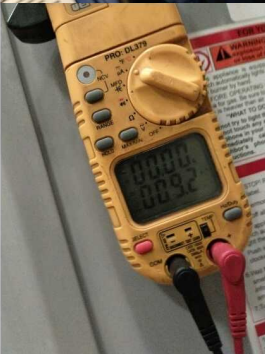
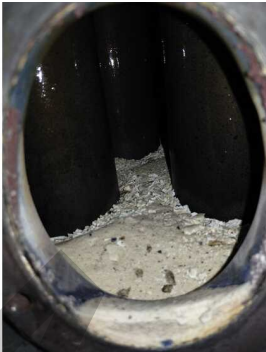
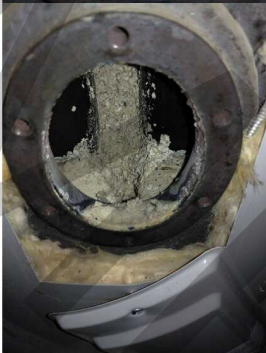
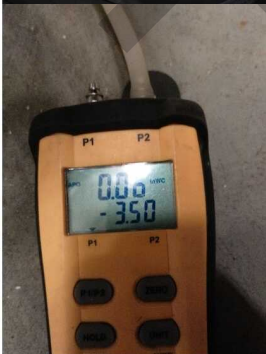
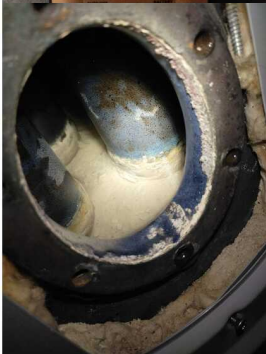
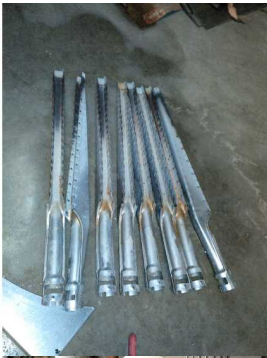
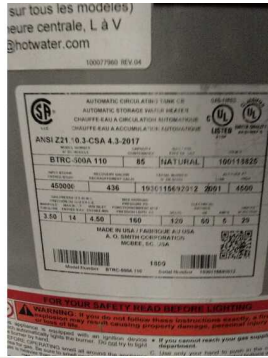
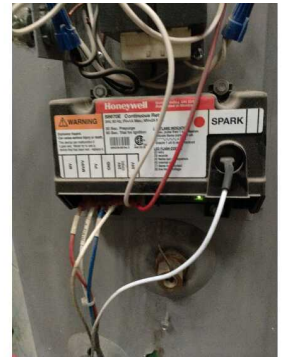
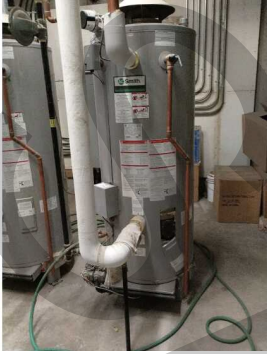
Asset Register - Hot Water Tank					
Asset ID	Make	Model	Serial	Location	Results
1010	AO Smith	BTRC500A 110		Mechanical Room	Fail
Test Reading:		Is the hot water tank operational upon arrival?: Yes are their any leaks? (Gas, vessel, venting, relief valve): No Is the combustion air clean and unobstructed? : Yes Flame signal (If weak Clean): Acceptable / Within Range Drain down, and open inspection port clean if required: Cleaned Clean and inspect burners and ignition components: Good condition Manifold pressure : Acceptable / Within Range Safety relief test: Pass Condensate trap inspected & cleaned (if applicable): Not applicable Setpoint : 135F (our standard)			
Test Notes: (If Applicable)		Ignition modules failing Nissan transformer internal to module is very loud 1 - Honeywell s8670e 2h

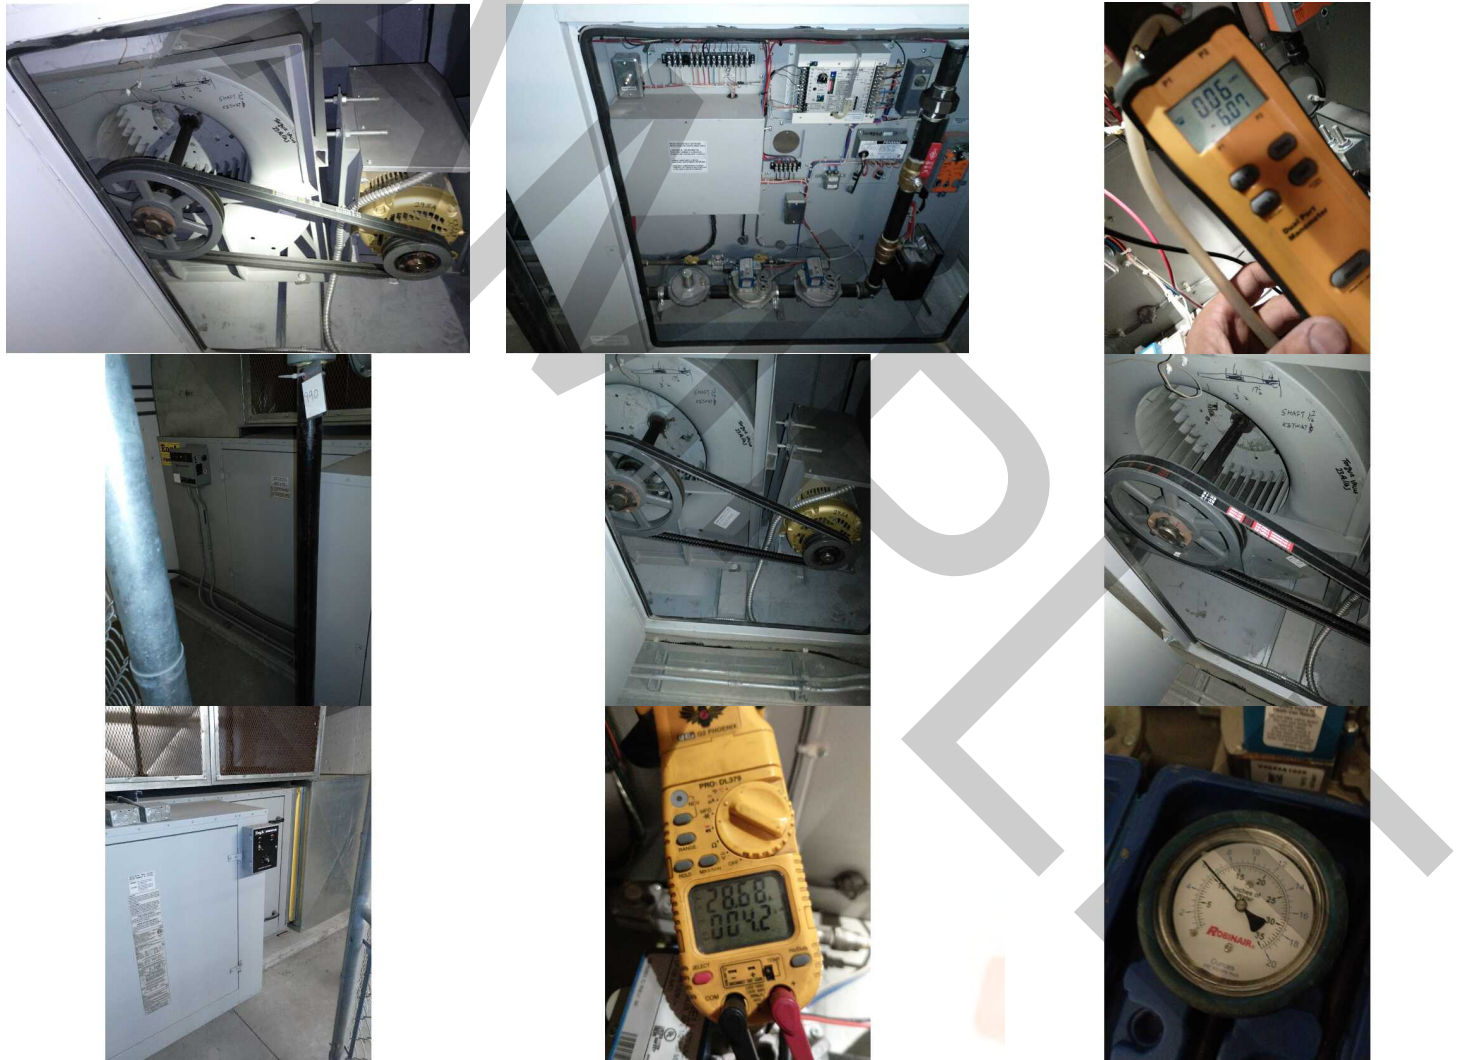
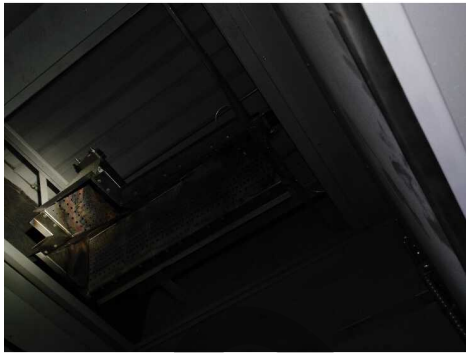
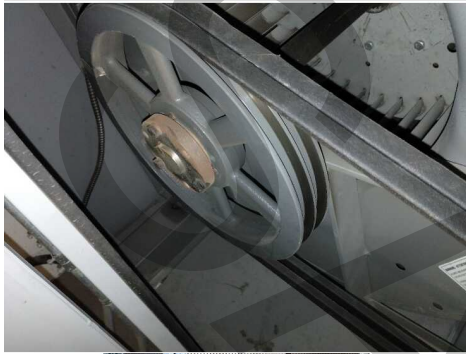
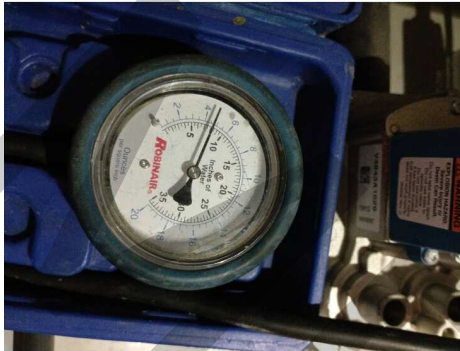
Photos: (If Applicable)

Asset Register - Make Up Air					
Asset ID	Make	Model	Serial	Location	Results
990	Engineered Air	HE131	S58448 -MUA – 6 - 2	Parkade	Pass
Test Reading:		Unit Operational: Yes			
		Internal Unit Condition (CLEAN IF REQUIRED): Clean (No action required)			
		Electrical Component Condition: Pass			
		Filter Condition: Good			
		Belt Condition: Replaced			
		Pulley Condition: Pass			
		Gas Manifold Pressure : Acceptable / Within Range			
		Gas Inlet Pressure : Acceptable / Within Range			
		Flame Condition: Blue			
		Burner Plates Condition: Pass			
		Spark Rod Condition (Clean if required with 300 Grit or Finer): Acceptable			
		Supply Fan Amperage: Acceptable / Within Range			
Test Notes: (If Applicable)		Is cooling present and is it operational?: N/A - Not Existing

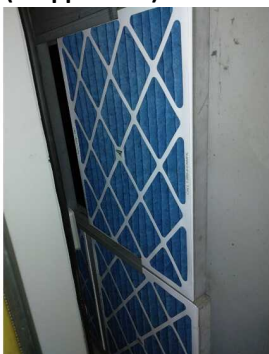
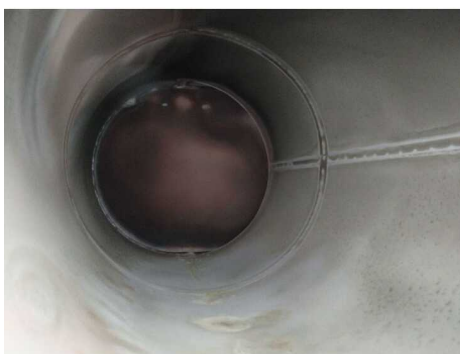
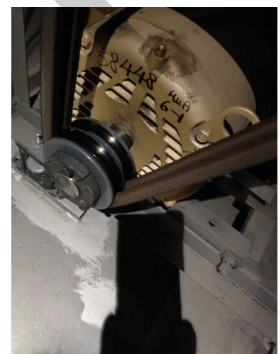
Photos: (If Applicable)

Asset Register - Make Up Air					
Asset ID	Make	Model	Serial	Location	Results
991	Engineered Air	DJS140	S58448 MUA-6-1	Mechanical Room	Pass
Test Reading:		Unit Operational: Yes Internal Unit Condition (CLEAN IF REQUIRED): Dirty (Cleaned during visit) Electrical Component Condition: Pass Filter Condition: Replaced Belt Condition: Replaced Pulley Condition: Pass Gas Manifold Pressure : Acceptable / Within Range Gas Inlet Pressure : Acceptable / Within Range Flame Condition: Blue Burner Plates Condition: Pass Spark Rod Condition (Clean if required with 300 Grit or Finer): Acceptable Supply Fan Amperage: Acceptable / Within Range Is cooling present and is it operational?: N/A - Not Existing			
Test Notes: (If Applicable)

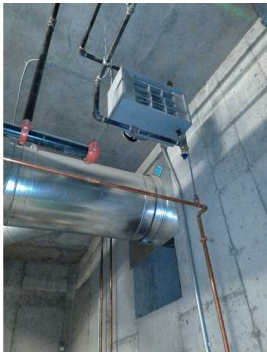
Photos: (If Applicable)

Asset Register - Unit Heater / Force Flow					
Asset ID	Make	Model	Serial	Location	Results
992	Rosemex	H18		Mechanical Room	Pass
Test Reading:		Is the unit leaking?: No Unit Set for seasonal temperature: 15C (Winter) Does the coil require cleaning? (If accessible): Acceptable Is the motor noisy during operation?: No Condition of the filter: Not Applicable			
Test Notes: (If Applicable)

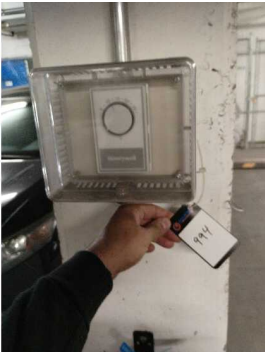
Asset ID	Make	Model	Serial	Location	Results
994	Rosemex	H50		Parking Stall B13	Pass

Is the unit leaking?: No
Unit Set for seasonal temperature: 15C (Winter)
Does the coil require cleaning? (If accessible): Acceptable
Is the motor noisy during operation?: No
Condition of the filter: Not Applicable

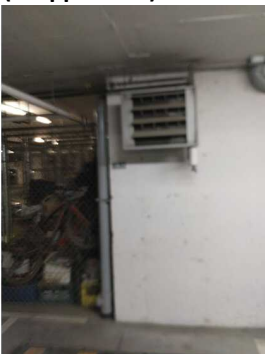
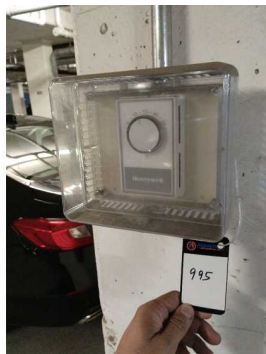
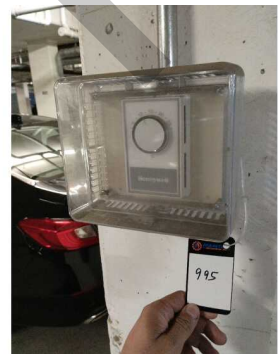
Asset ID	Make	Model	Serial	Location	Results
995	Rosemex	H50		Parking Stall B30	Pass

Is the unit leaking?: No
Unit Set for seasonal temperature: 15C (Winter)
Does the coil require cleaning? (If accessible): Acceptable
Is the motor noisy during operation?: No
Condition of the filter: Not Applicable

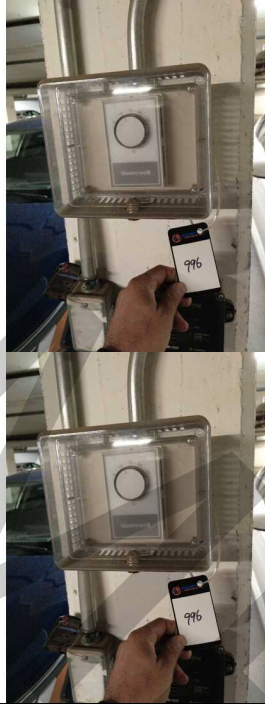
Asset Register - Unit Heater / Force Flow					
Asset ID	Make	Model	Serial	Location	Results
996	Rosemex	H50		Parking Stall B67	Pass
<p>Test Reading:</p> <p>Is the unit leaking?: No Unit Set for seasonal temperature: 15C (Winter) Does the coil require cleaning? (If accessible): Acceptable Is the motor noisy during operation?: No Condition of the filter: Not Applicable</p> <p>Test Notes: (If Applicable)</p>

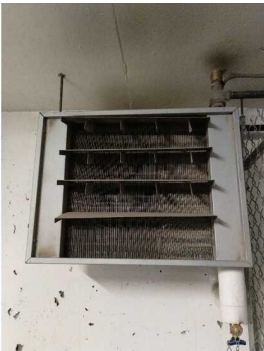
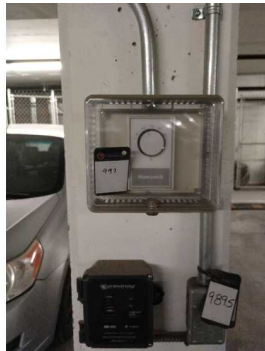
Asset Register - Unit Heater / Force Flow					
Asset ID	Make	Model	Serial	Location	Results
997	Rosemex	H50		Parking Stall B88	Pass
<p>Test Reading:</p> <p>Is the unit leaking?: No Unit Set for seasonal temperature: 15C (Winter) Does the coil require cleaning? (If accessible): Acceptable Is the motor noisy during operation?: No Condition of the filter: Not Applicable</p> <p>Test Notes: (If Applicable)</p>

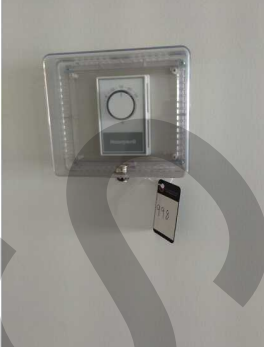
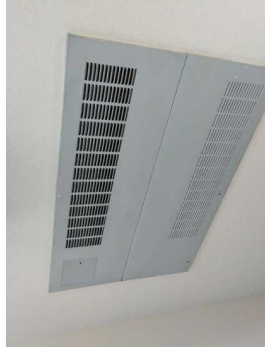
Asset Register - Force Flow / Unit Heater					
Asset ID	Make	Model	Serial	Location	Results
998	Rosemex	F300		Front Lobby	Pass

Is the unit operational?: Yes
Unit Set for seasonal temperature : 15C (Winter Setting)
Does the coil require cleaning? (if accesible): No coil is currently clean
Is the motor noisy during operation?: No
Condition of the filter: Not Applicable

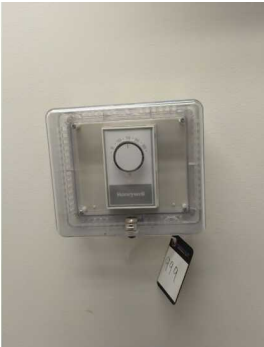
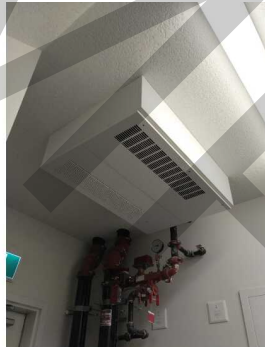
Asset ID	Make	Model	Serial	Location	Results
999	Rosemex	F300		Back Door by Elevator	Pass

Is the unit operational?: Yes
Unit Set for seasonal temperature : 15C (Winter Setting)
Does the coil require cleaning? (if accesible): No coil is currently clean
Is the motor noisy during operation?: No
Condition of the filter: Not Applicable

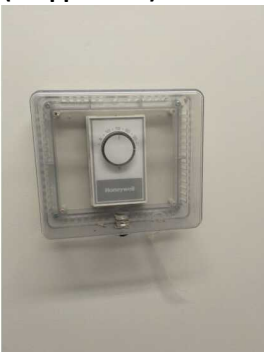
Asset ID	Make	Model	Serial	Location	Results
1000	Rosemex	F300		West Stairwell	Pass

Is the unit operational?: Yes
Unit Set for seasonal temperature : 15C (Winter Setting)
Does the coil require cleaning? (if accesible): No coil is currently clean
Is the motor noisy during operation?: No
Condition of the filter: Not Applicable

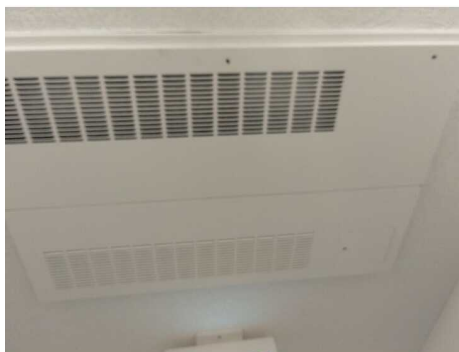
Asset Register - Exhaust Fan (Large)					
Asset ID	Make	Model	Serial	Location	Results
1001	Cook	360 XMWH		Parkade stall A79	Pass
Test Reading:		Unit Operational: Yes Motor Amperage: Acceptable / Within Range Belt Condition : Replaced Pulley Condition: Pass Interlock Functions with MUA: Yes Disconnect kills power to fan?: Yes Electrical Condition / Damper Condition: Pass			
Test Notes: (If Applicable)

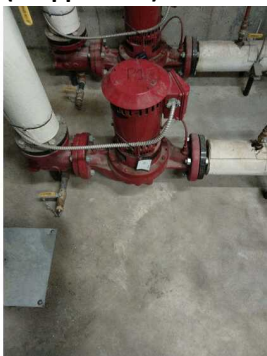
Asset Register - Pump					
Asset ID	Make	Model	Identification Number (date code or serial number)	Location	Results
1004	WEG			Mechanical Room	Pass
Test Reading:		Is the pump operational and leak free?: Fully operational & no leaks Check incoming voltage & amp draw (If safe to do so): Acceptable / Within Range Verify correct rotation : Pass Cycle pumps : Automatic cycle Check pump strainer (If applicable) : Cleaned			
Test Notes: (If Applicable)

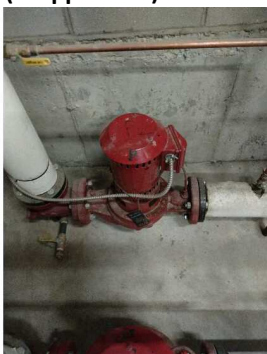
1005				Beside Elevator	Pass
Test Reading:		Visual walkthrough, note any signs of failure: No Review controller to verify operation: Operational Check floats for operation: Pass Motor Amperage: Acceptable / Within Range Note condition of pit: Clean			
Test Notes: (If Applicable)

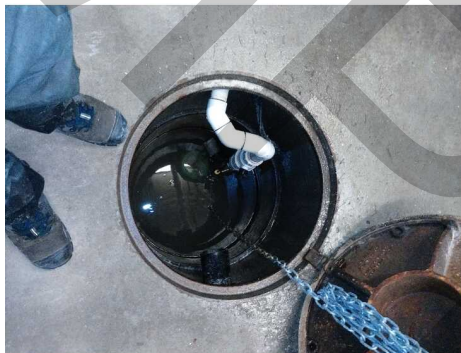
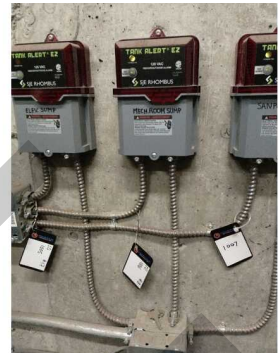
Asset Register - Sump Pump					
Asset ID	Make	Model	Serial	Location	Results
1006				Mechanical Room	Pass
Test Reading:		Visual walkthrough, note any signs of failure: No Review controller to verify operation: Operational Check floats for operation: Pass Motor Amperage: Acceptable / Within Range Note condition of pit: Clean			
Test Notes: (If Applicable)

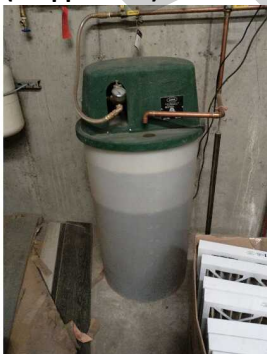
Asset ID	Make	Model	Serial	Location	Results
1011	Axiom	SF100		Mechanical Room	Pass
Test Reading:		Inspect for leaks: No leaks Tank Level: Acceptable (More than Half) Cycle to inspect operation: Acceptable Glycol Condition: Acceptable (No Mold)			
Test Notes: (If Applicable)

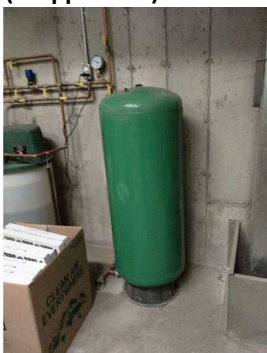
Asset ID	Make	Model	Serial	Location	Results
1012	Pro Flex 2	PH25		Mechanical Room	Pass
Test Reading:		Visually inspect for leaks: Pass Check Air Sifter for Moisture: Pass Annually drain down and set pre-charge air pressure (and record): Acceptable			
Test Notes: (If Applicable)

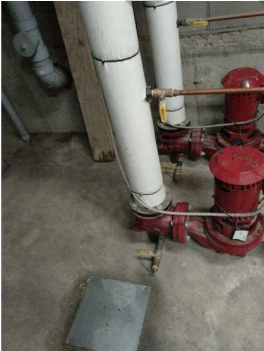
Asset ID	Make	Model	Location	Results
1015	B&G	DC-3X		Pass

Is this component leaking?: No
Was the unit cleaned?: Yes (This visit)

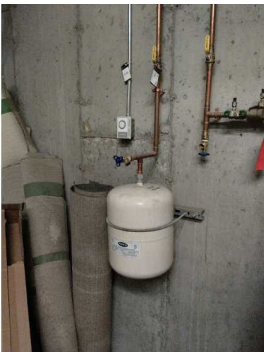
Asset ID	Make	Model	Serial	Location	Results
1016	Flexcon	SHXT160		Mechanical Room	Pass

Visually inspect for leaks: Pass
Check Air Sifter for Moisture: Pass
Annually drain down and set pre-charge air pressure (and record): Acceptable

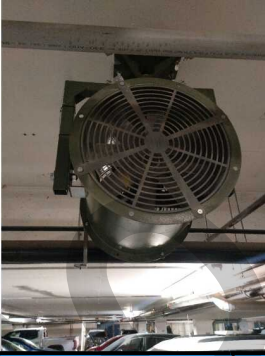
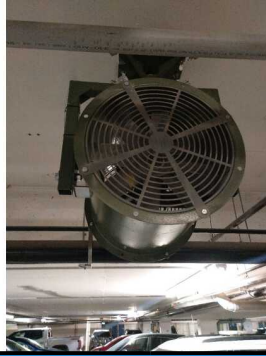
Unit Operational: Yes
Motor Amperage: Acceptable / Within Range
Belt Condition : Not Applicable
Pulley Condition:
Interlock Functions with MUA: Yes

Disconnect kills power to fan?: Yes
Electrical Condition / Damper Condition: Pass

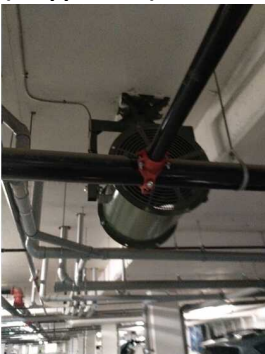
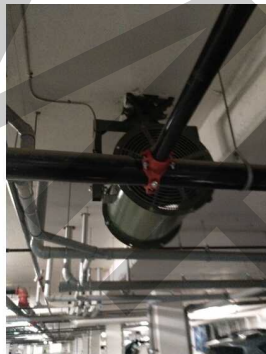
Asset Register - Exhaust Fan (Large)

Asset ID	Make	Model	Serial	Location	Results
7570	Canarm	MCY18T10033C		Parking stall B74	Pass

Unit Operational: Yes
Motor Amperage: Acceptable / Within Range
Belt Condition : Not Applicable
Pulley Condition:
Interlock Functions with MUA: Yes
Disconnect kills power to fan?: Yes
Electrical Condition / Damper Condition: Pass

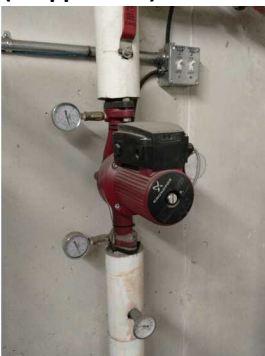
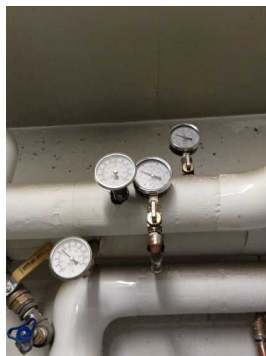
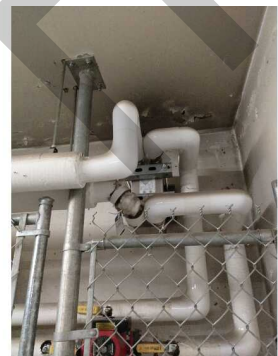
Asset Register - Heat Exchanger

Asset ID	Make	Model	Serial	Location	Results
8498	?	?		Snow Melt	Pass

Are there any obvious signs of failure?: No
Temperature differential: Acceptable

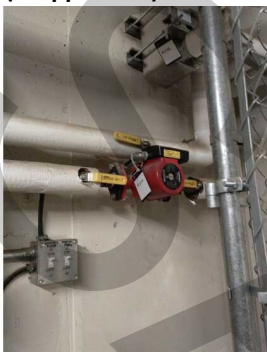
Asset Register - Pump

Asset ID	Make	Model	Identification Number (date code or serial number)	Location	Results
8500	Armstrong	Astro 280ci		Snow Melt	Pass
Test Reading: Is the pump operational and leak free?: Fully operational & no leaks Check incoming voltage & amp draw (If safe to do so): Acceptable / Within Range Verify correct rotation : Pass Cycle pumps : Automatic cycle Check pump strainer (If applicable) : Not applicable Test Notes: (If Applicable)

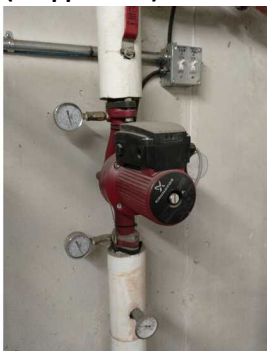
Asset Register - Pump					
Asset ID	Make	Model	Identification Number (date code or serial number)	Location	Results
8501	Grundfos	UPS 32-160 F	96402730	Snow Melt	Pass
Test Reading: Is the pump operational and leak free?: Fully operational & no leaks Check incoming voltage & amp draw (If safe to do so): Acceptable / Within Range Verify correct rotation : Pass Cycle pumps : Automatic cycle Check pump strainer (If applicable) : Not applicable Test Notes: (If Applicable)

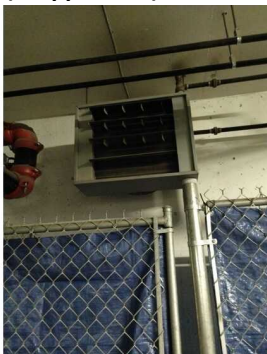
Photos: (If Applicable)

Asset ID	Make	Model	Serial	Location	Results
8508	Rosemex	H-50		Stall B81	Pass
Test Reading:		Is the unit operational?: Yes Unit Set for seasonal temperature : 15C (Winter Setting) Does the coil require cleaning? (if accesible): No coil is currently clean Is the motor noisy during operation?: No Condition of the filter: Not Applicable			
Test Notes: (If Applicable)
