# ***A Buyer's Choice Home Inspections***

## **Property Inspection Report**

627 Marian Crescent NE, Calgary, AB, T2A 2Y5

Date of Inspection: 1/16/2016 Time: 9:00 AM  
Order ID: 272

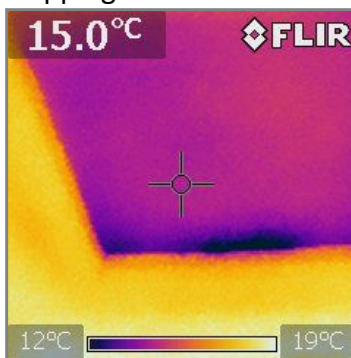
Thermal imaging shows heat loss at attic hatch

Dark areas in thermal imaging indicate heat loss due to poor insulation and weather stripping missing on attic hatch

Recommend installing weather stripping around attic hatch

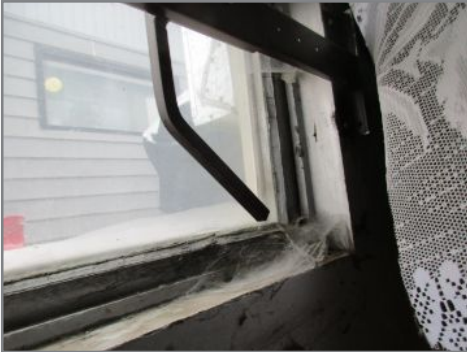
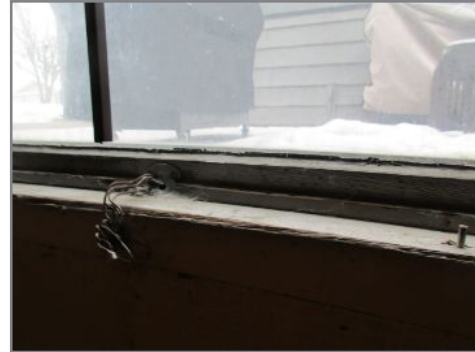
- Hardware missing on windows so could not test it.

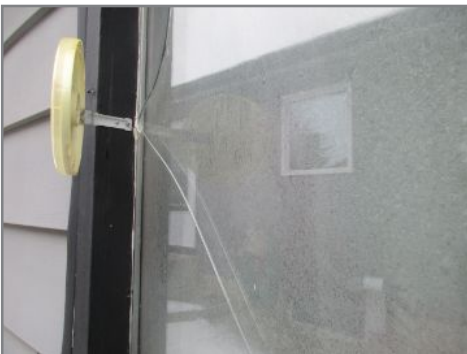
- Windows appeared functional at time of inspection.
- Trim around south window has come loose. Recommend sealing this to keep moisture out of the subwall.
- Cracked or broken window glass was observed. Injury could occur. Recommend repair or replacement of the damaged glass.

Window pane is cracked

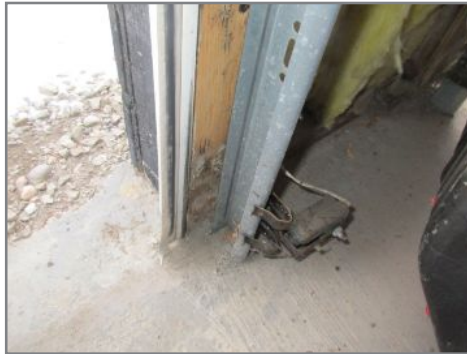
Infra Red Safety Device functioned at inspection

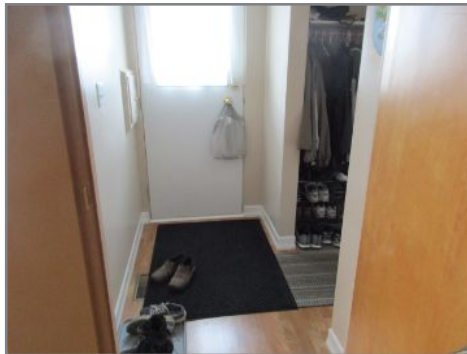
Back entrance

- Hollow wood door noted.
- Wood door noted.
- Wood door with glass panes noted.
- Sliding patio door noted.
- No function concerns noted at time of inspection.
- Weather stripping is not installed on back and front doors.

Recommend installing weather stripping on exterior doors

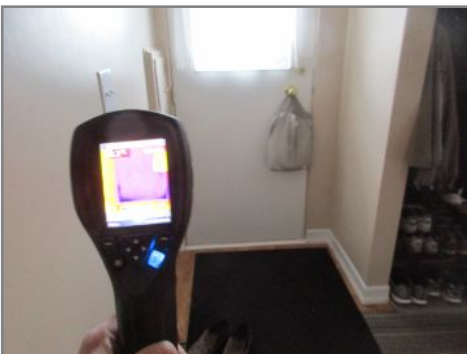
Thermal imaging shows heat loss around doors

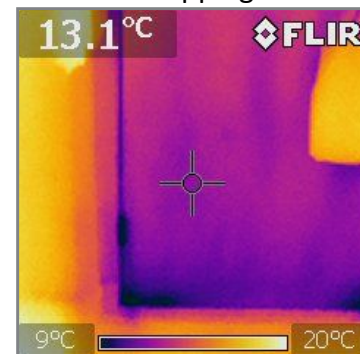
Heat loss around doors is observed with thermal imaging due to missing weather stripping

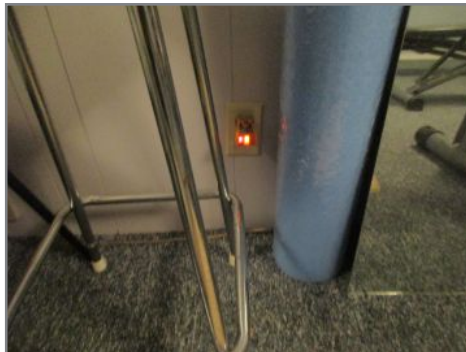
This outlet in the basement family room is reversed wired

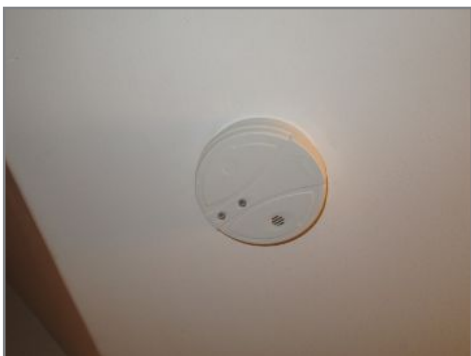
Basement family room

- Smoke detector is located in common hallway.
- Operated when tested.

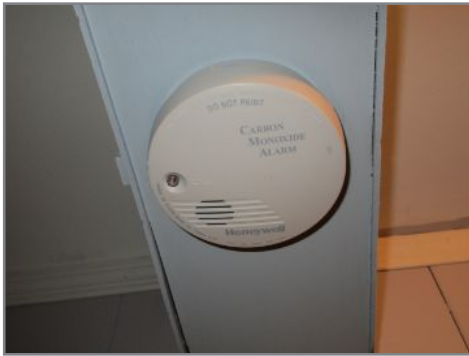
Basement family room

- **SAFETY INFO:** Carbon Monoxide (CO) is a lethal gas--invisible, tasteless, odorless--produced in normal amounts whenever you use an appliance which burns a combustible fuel--gas, oil, kerosene, charcoal, and wood. When proper ventilation becomes blocked or inadequate, CO concentrations build up inside your home and become deadly.
- Carbon monoxide detector alarm sounded when tested at time of inspection.

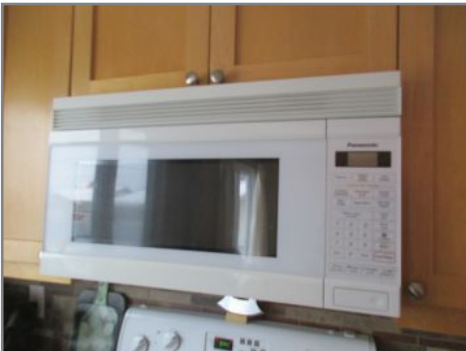
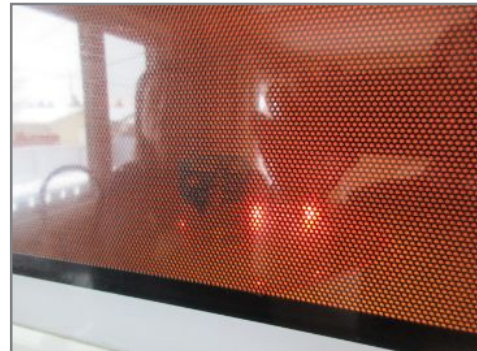
- Panasonic
- Built-in microwave ovens are tested using normal operating controls and a microwave sensor. Unit was tested and appeared to be serviceable at time of inspection. Leak and/or efficiency testing is beyond the scope of this inspection. If concerned, client should seek further review by qualified technician prior to closing.

Orange glow indicates presence of microwaves

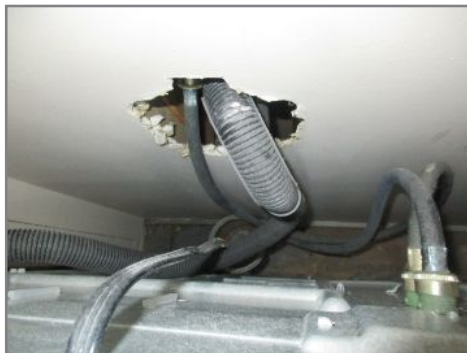
- Plumbing appeared to be properly installed at time of inspection.
- Wall mounted drain noted.
- Rotary valves noted for laundry taps
- No floor drain was noted. Floor drains are recommended for main floor or higher laundry in case the washing machine should fail. This could result in flooding of the floor and floors below. Recommend a qualified plumber install drain and /or catch pan.

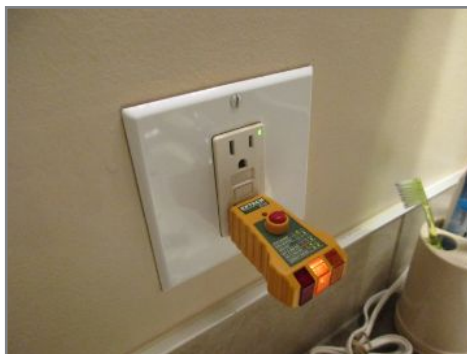
Observations: **GFCI in main bathroom tested and found to be improperly wired. Recommend review and repair by Qualified Electrician.**

This GFCI outlet has an open ground and should be replaced
